## CHAPTER 9

### MICROSTRUCTURES of WORN DISCS

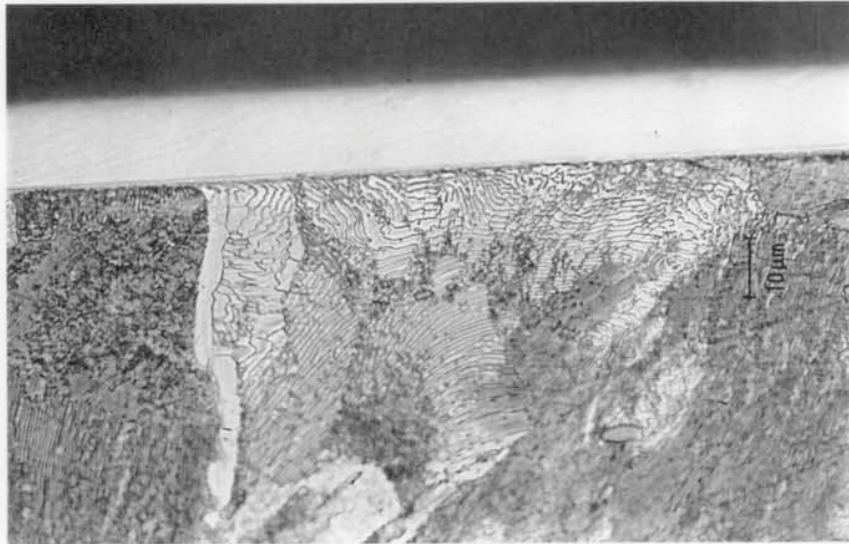
A section through the top R52 disc is shown in Figure 9.1, no surface ratchetting is evident. Micro-hardness surveys of both sections showed that the work-hardening peak was sub-surface, as expected (cf. Chapter 3). It also showed that no hardening had occurred towards the surface (Figure 9.2).

**Figure 9.1** Wear surface circumferential section through a R52 top disc, Amsler tested at 1300 MPa maximum contact stress,  $p_o$ , and *zero* creepage,  $\gamma$ , (i.e. pure rolling) for 50000 revolutions.

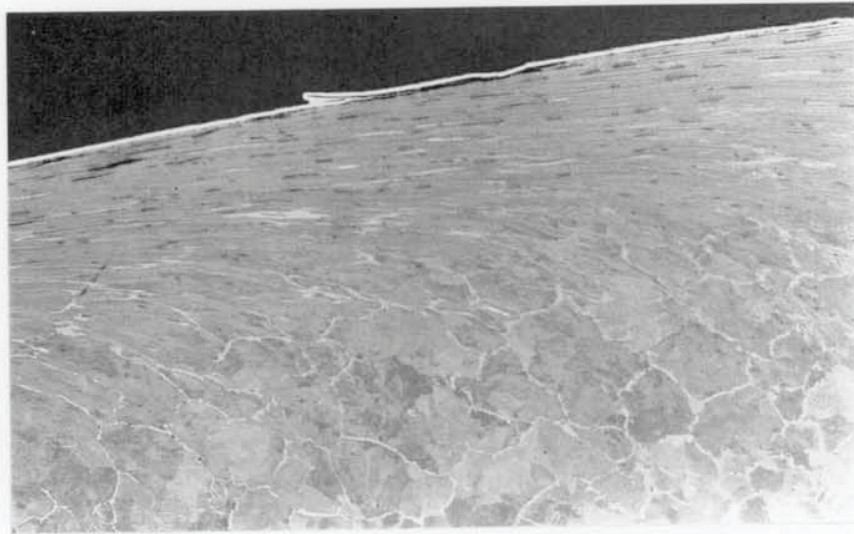
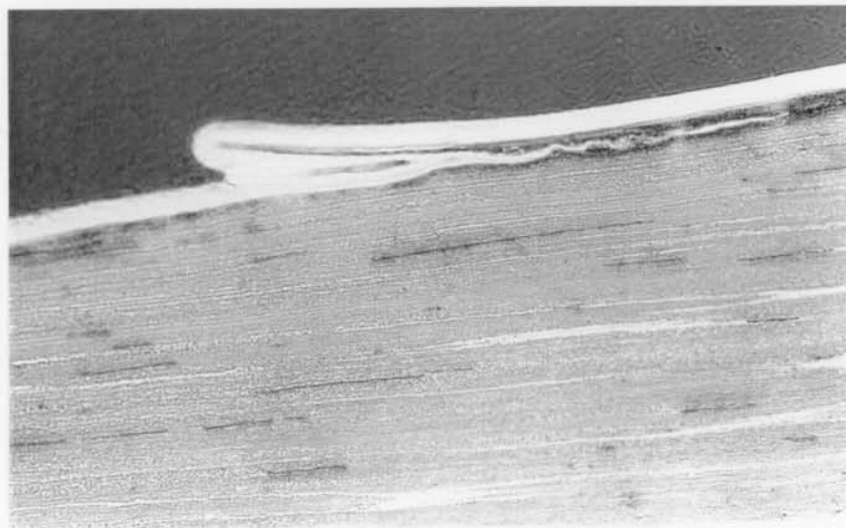
When, again at 1300 MPa  $p_o$ , an element of low slip or creepage was introduced, relatively heavy wear took place, with a high degree of surface distortion. (eg. Amsler Test 9 with 3% creepage  $\{\gamma\}$ .) Sections through the Test 9 R52 top driven disc and W64 bottom driving disc are shown in Figures 9.3 and 9.4, respectively. In both discs, the matrix had been strained to such a degree that ferrite areas and cementite lamellae within pearlite were near-parallel to the surface. The cementite

lamellae had both fractured and plastically deformed in the process of alignment. (This feature is more clearly shown in the TEM micrographs discussed in Section 9.6.)

**Figure 9.3** Wear surface circumferential section through a R52 top driven (i.e. "braking") disc, Amsler tested at 1300 MPa  $p_o$  and 3%  $\gamma$  (Test 9).  
(a) Overview showing "ratchetting" (i.e. cyclic, directional matrix strain) and surface flake. Wear by thin flake tip fracture.  
(b) Near-parallel matrix strain at the surface and pancaked MnS inclusion stringer cross sections.

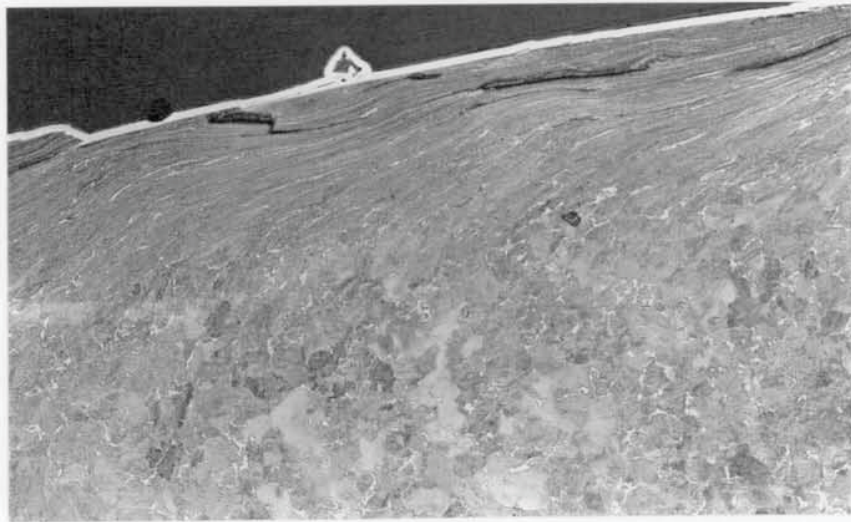
**Figure 9.4** Wear surface circumferential section through a W64 bottom driving disc, Amsler tested against R52 at 1300 MPa  $p_o$  and 3%  $\gamma$  (Test 9). (a) Overview. For driving discs, typical fracture of flakes near their root. (b) Aligned structure within a flake.

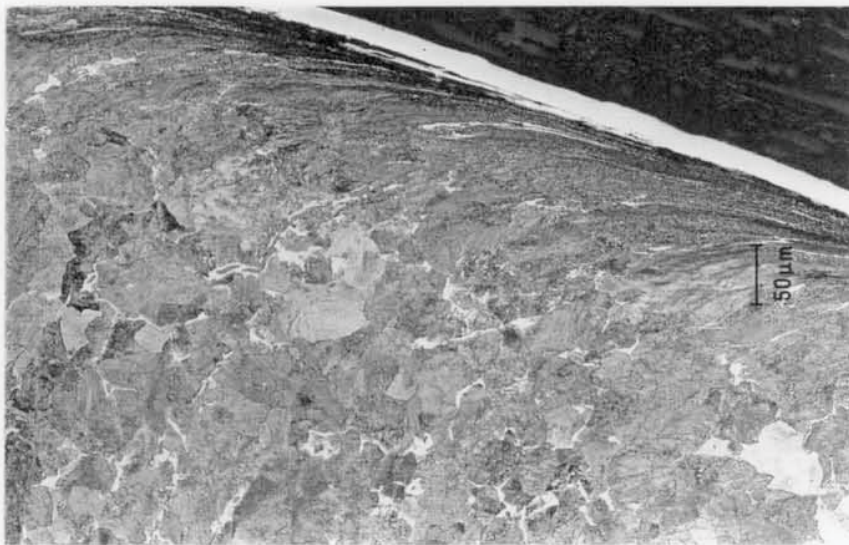
Comparative wear curves are shown in Figure 8.17. The R52/W64 worn microstructures from Test 7 are shown in Figure 9.6 and the respective hardness

curves in Figure 9.7. Comparing both figures with those for Test 9 (1300 MPa  $p_o$ , 3%  $\gamma$ ; Figures 9.3, 9.4 and 9.5), it can be seen that matrix strain and work hardening were considerably reduced at this lower contact stress, as was track width spread (9.5%). Microstructural events, generated by matrix strain, appeared similar to those seen at the higher contact stress for the top driven R52 disc. They were also similar for the bottom driving disc with respect to cementite lamellae distortion, alignment and fracture, however surface flakes were thinner and fatigue fracture had taken place at flake tips, rather than through flake bodies, as seen at the higher contact stress. This difference was reflected in the W64 wear rate patterns for these two tests (cf. Tests 9 and 7, Figures 8.2 and 8.3).

**Figure 9.6** Wear surface circumferential sections through (a) R52 top disc and (b) W64 bottom disc, Amsler tested at 900 MPa  $p_o$  and 3%  $\gamma$  (Test 7). Shallower ratchetting at this contact stress.

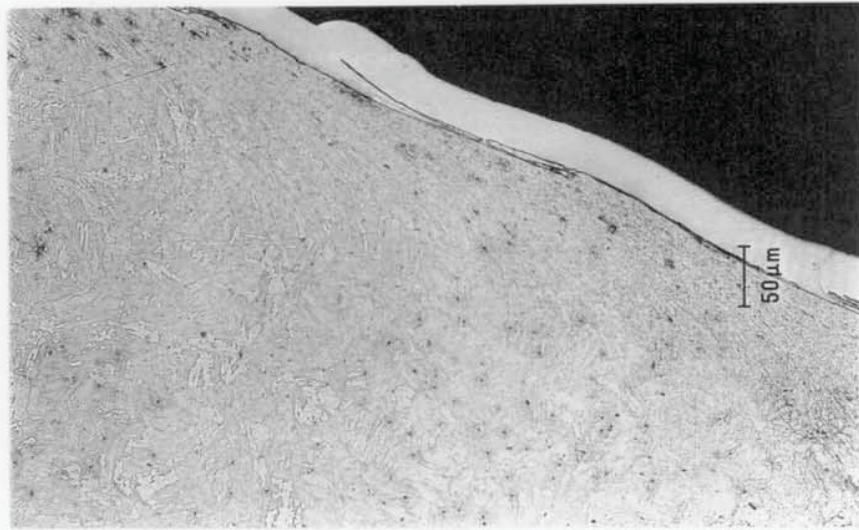
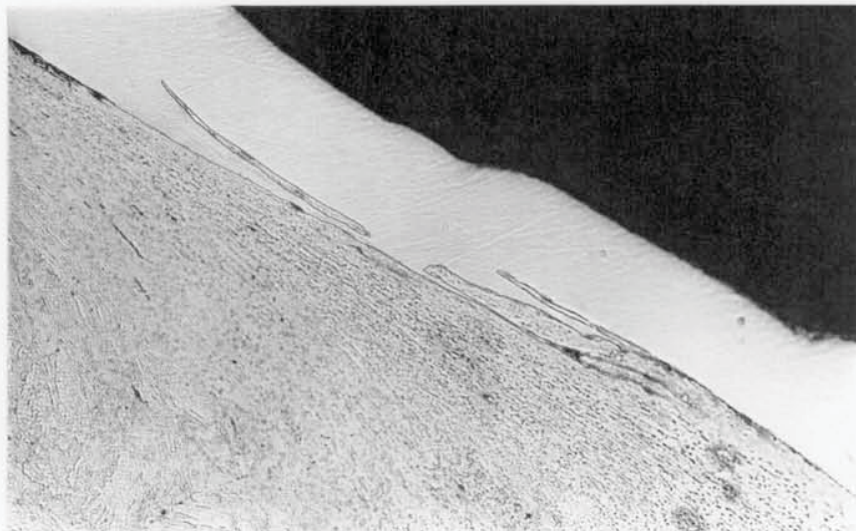
Circumferential sections through the B04 top driven disc and W64 bottom driving disc are shown in Figures 9.8 and 9.9, respectively. Microhardness curves are shown in Figure 9.10. The B04 disc hardened up to a similar near-surface value to the Test 7 R52 disc, however, as the initial bulk hardness was higher, the degree of work hardening was less. The wear rates of both discs were considerably higher than those of Test 7 (Figures 8.2 and 8.3), as was track width spread (Table 6.3). The B04 micrographs in Figure 9.8 indicate that thin flakes were rapidly formed and eroded away and that the near-surface structure was ratchetted in a similar manner to pearlite tested under these conditions. The MnS content of this steel was low and MnS inclusions appear to have had a minimal effect on the wear process. (This also applied to the other two bainitic steels.)

**Figure 9.8** Wear surface circumferential section through a B04 top driven disc, Amsler tested at 900 MPa  $p_0$  and 3%  $\gamma$  (Test 16).  
(a) Overview showing ratchetting and surface flake.  
(b) Shallow near-surface ratchetting; wear by thin flake tip fracture.

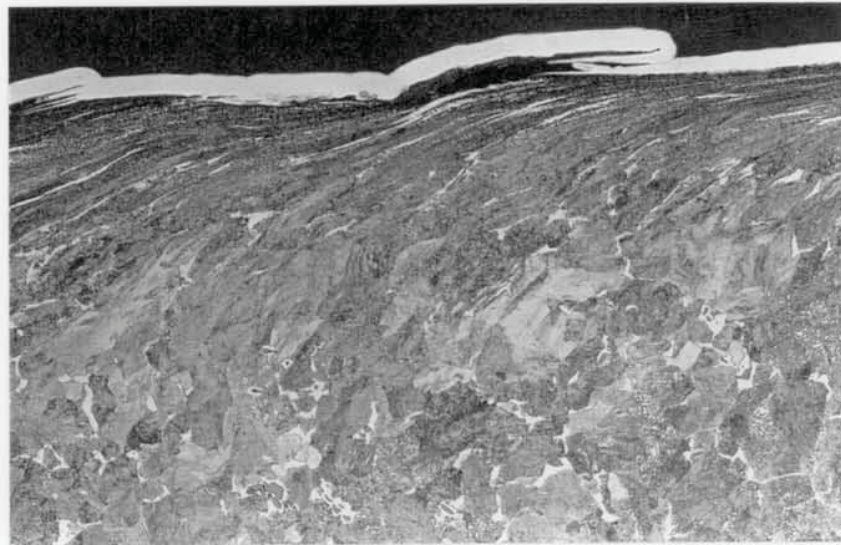
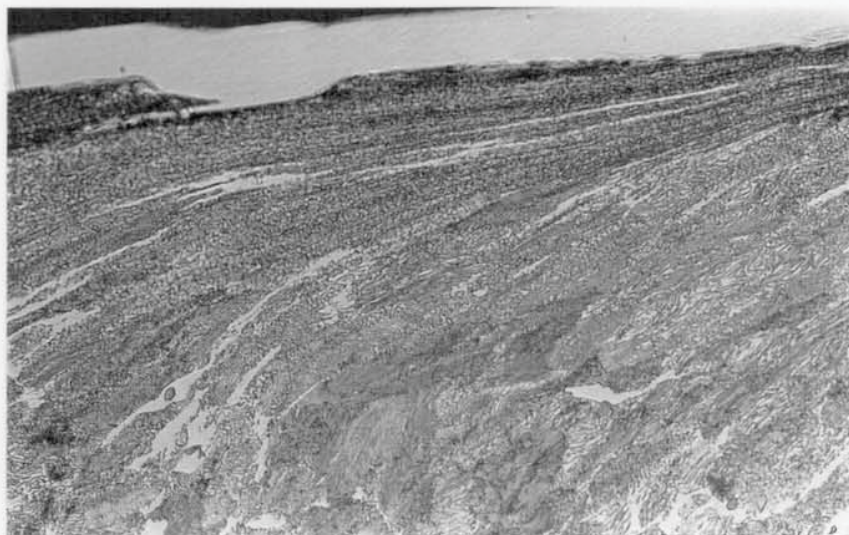
The hard (MA) phase particles in this bainite were sparser and far more regularly shaped than hard phase (cementite) lamellae in pearlite. They were re-aligned by matrix strain, but barely re-shaped or fractured; i.e. compared to pearlite, more soft ferrite phase would have been presented to the wear face. This, in turn, resulted in more adhesive wear and surface disruption of both discs (Figures 9.8 and 9.9). Disruption of lamellae alignment in the W64 disc reduced its wear resistance, hence its higher wear rate than the W64 disc of Test 7. However, even the semi-alignment of cementite lamellae kept the W64 disc wear rate below that of the B04 top disc.

**Figure 9.9** Wear surface circumferential section through a W64 bottom driving disc, Amsler tested against B04 at 900 MPa  $p_o$  and 3%  $\gamma$  (Test 16). The surface is more disrupted compared with the section shown in Figure 9.6b.

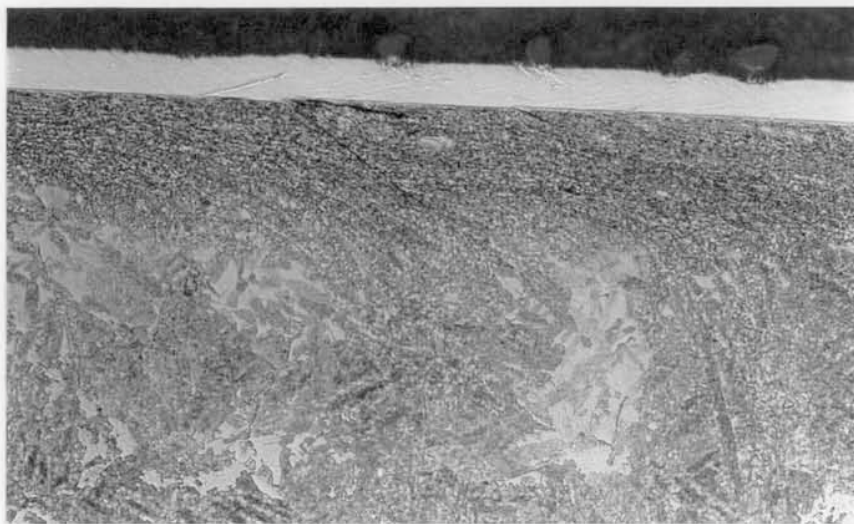
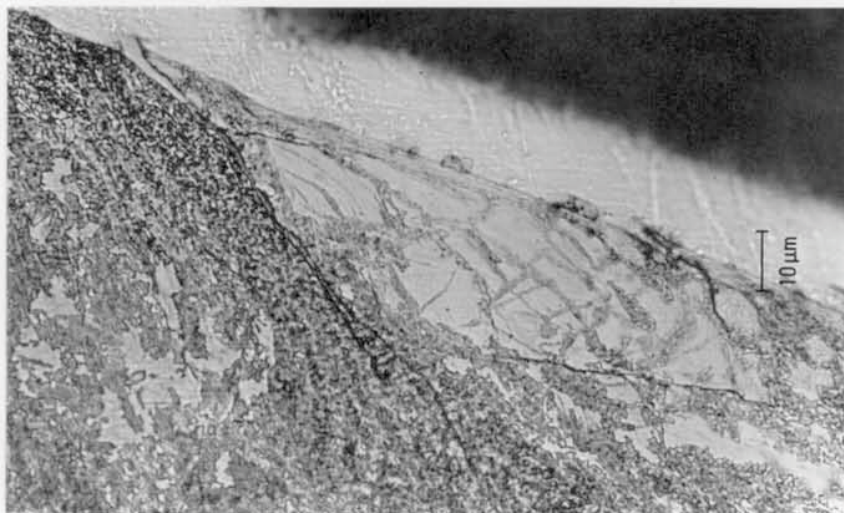
The upper bainitic areas accommodated more matrix strain than the martensite / lower bainitic areas. Under these test conditions, this resulted in wear surface cracks developing between the two structures (Figure 9.11). However, *no* material was observed to have spalled from the surface of any B52 disc; i.e. such cracks were retained. Only minor, isolated flakes formed on this B52 wear surface. The wear rate was extremely low (Figures 8.2 and 8.3). Near-surface hardening above bulk level was minimal (Figure 9.13).

**Figure 9.11** Wear surface circumferential section through a B52 top driven disc, Amsler tested at 900 MPa  $p_o$  and 3%  $\gamma$  (Test 14).  
(a) Close view showing shallow ratchetting and fine surface fracture below a small flake.  
(b) Detail, showing rigidity of lower bainite / martensite zones near the surface.  
(c) Fracture between the strained upper bainite matrix and rigid lower bainite / martensite zone at the wear surface.

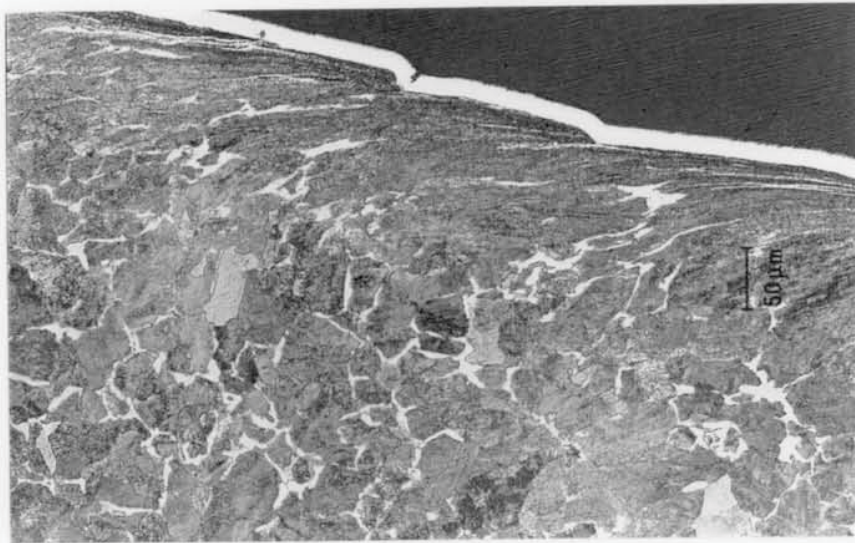
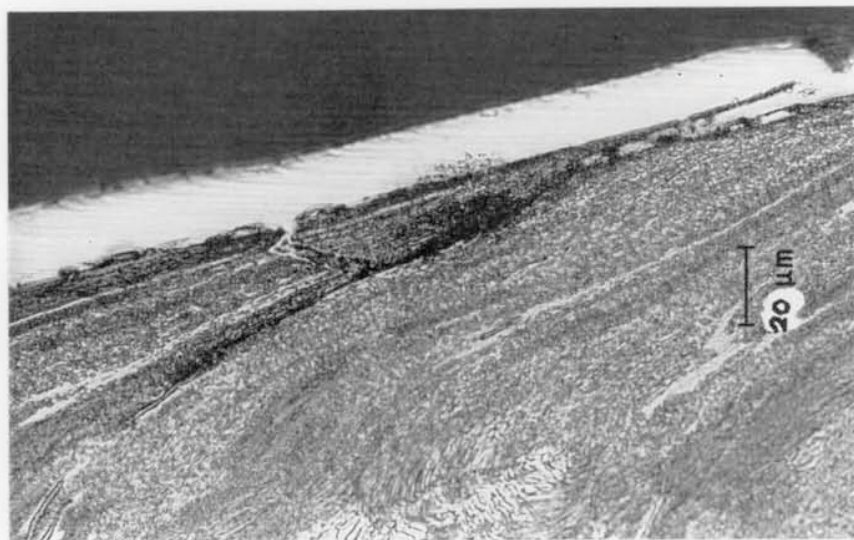
The companion W64 disc had hardened up considerably compared with W64 discs from the other two tests. The pattern of near-surface matrix strain, and the formation of thick flakes which had fractured off well away from flake tips (Figure 9.12), was similar to that seen on the R52/W64 1300 MPa  $p_o$  test (Figure 9.4), but on a lesser scale. The frequency of these events must have been low as this was the lowest W64 wear rate under these conditions (Figures 8.2 and 8.3).

**Figure 9.12** Wear surface circumferential section through a W64 bottom driving disc, Amsler tested against B52 at 900 MPa  $p_o$  and 3%  $\gamma$  (Test 14). Undulating surface from block fracture of surface flakes.

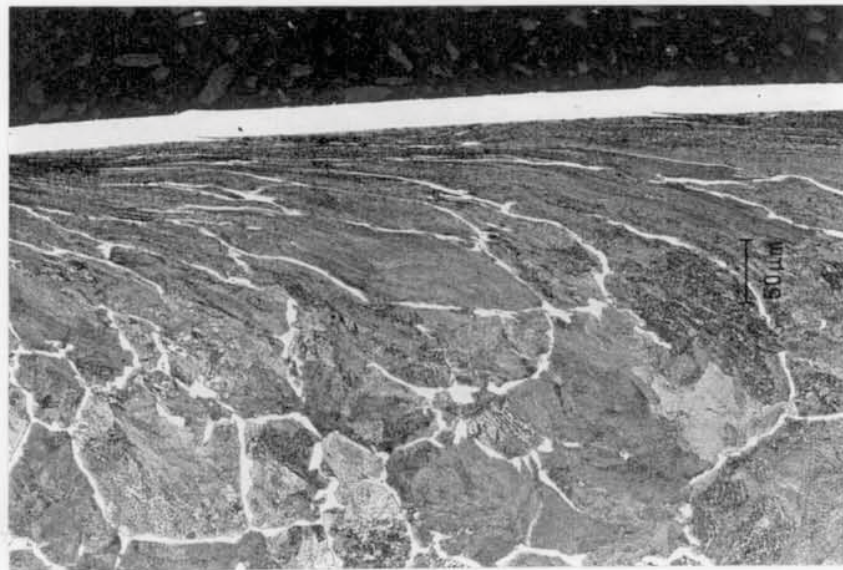
(X170 mag.)

**Figure 9.14** Wear surface circumferential section through a R52 top driven disc, LEROS tested at 900 MPa  $p_o$  and 3%  $\gamma$  (Test 30). *Section through a facet peak.*

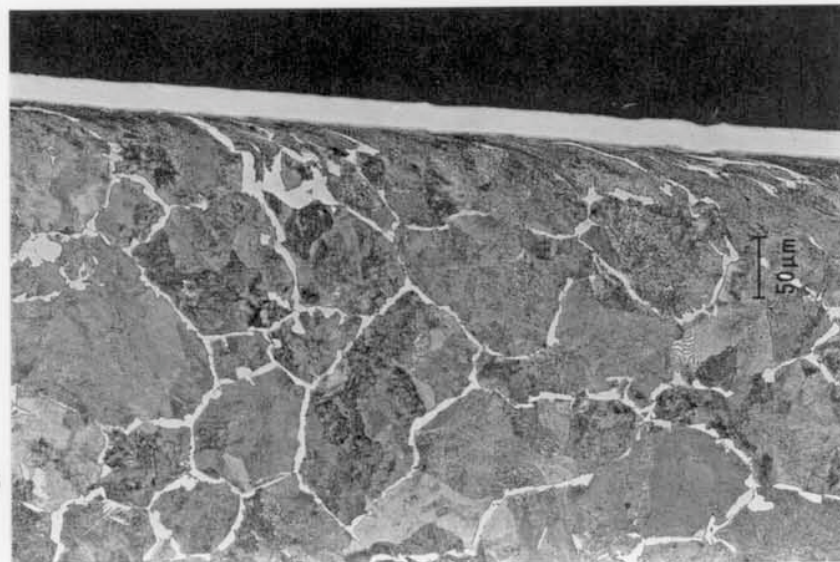
(X170 mag.)

**Figure 9.15** Wear surface circumferential section through a R52 top driven disc, LEROS tested at 900 MPa  $p_o$  and 3%  $\gamma$  (Test 30). *Section through a facet trough. Less ratchetting than seen on the facet peak.*

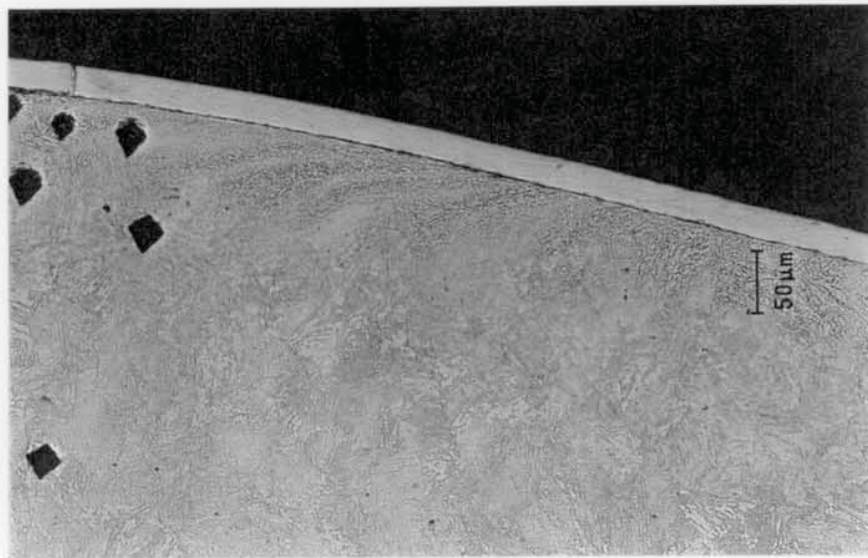
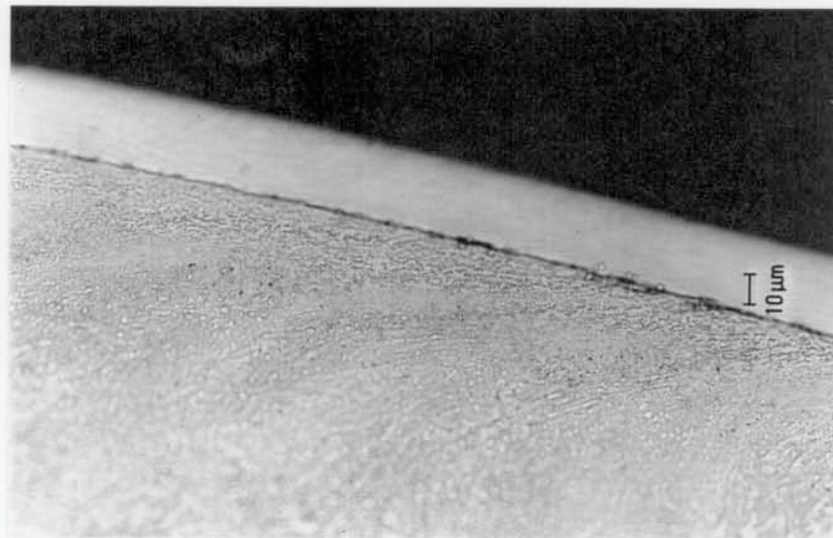
**Figure 9.17** Wear surface circumferential section through a B20 top driven disc, LEROS tested at 900 MPa  $p_o$  and 3%  $\gamma$  (Test 37). *Section through a facet peak.*

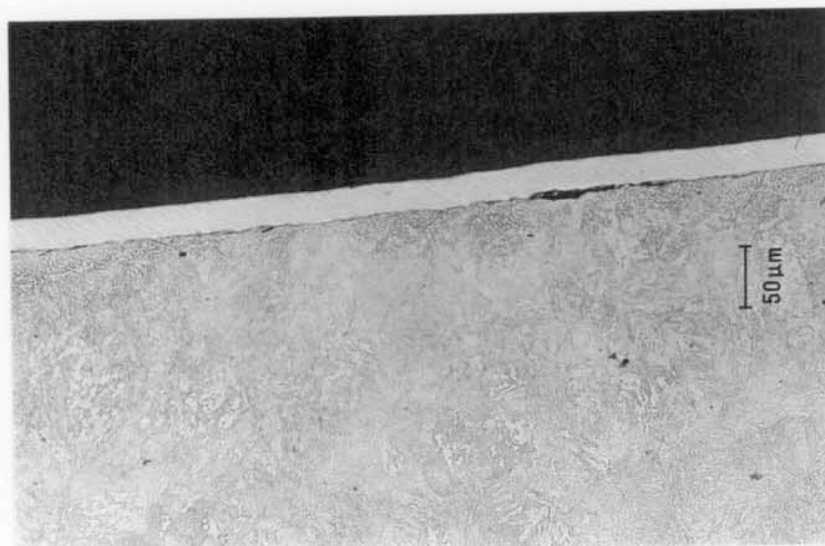
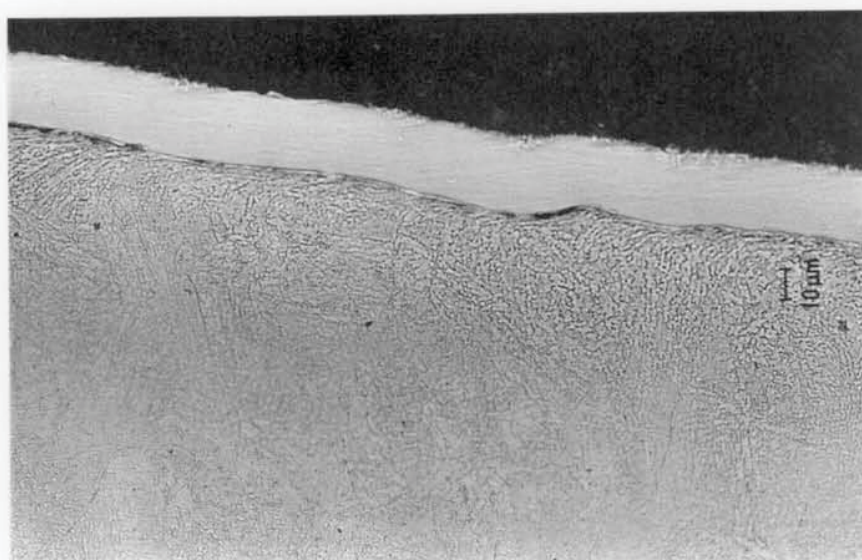
**Figure 9.18** Wear surface circumferential section through a B20 top driven disc, LEROS tested at 900 MPa  $p_o$  and 3%  $\gamma$  (Test 37). *Section through a facet trough. Less ratchetting than seen on the facet peak.*

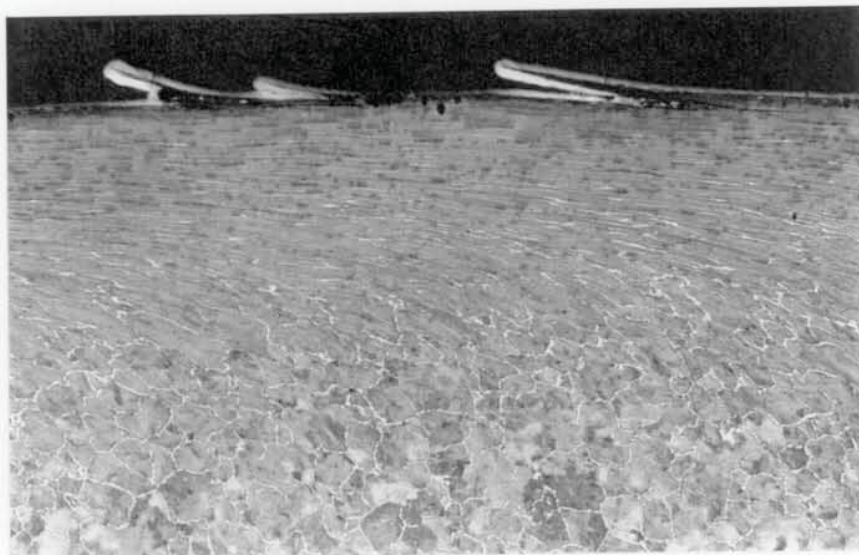
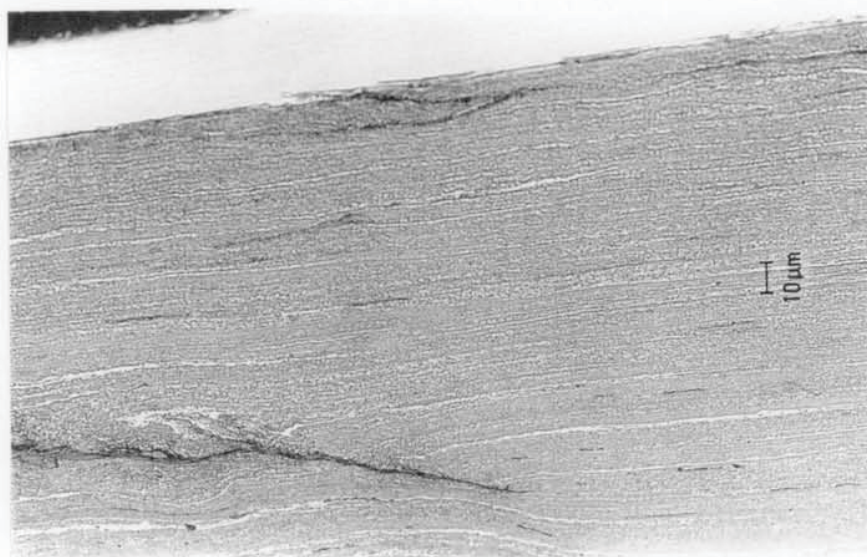
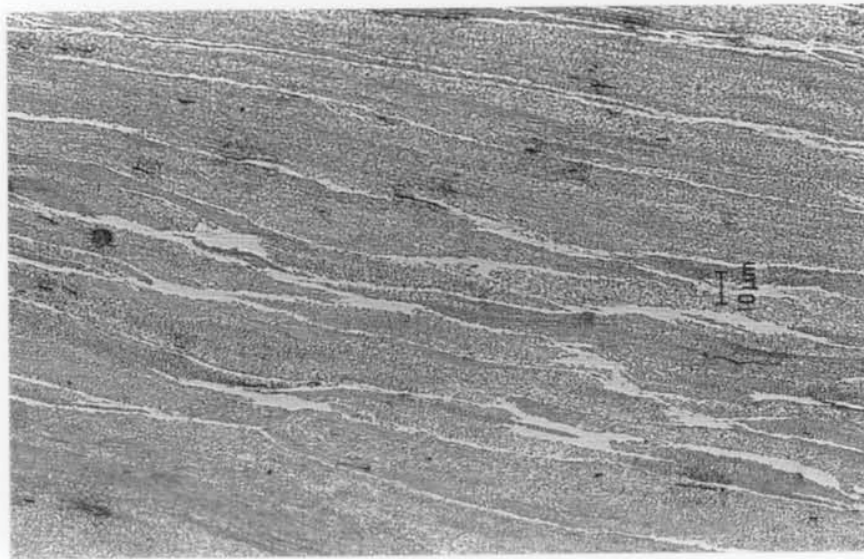
All top discs and one bottom disc were sectioned. The R52 micro-structure, shown in Figure 9.20, was extensively ratchetted, with clear and deep alignment of fractured cementite lamellae and pancaked MnS stringers. Flake roots were as deep as 150 $\mu$ m and flake crack walls were undulating. This suggested that there had been a high rate of plastic flow of the flake material over the bulk (Figure 9.20b). The hardness profile is shown in Figure 9.21. This reflects the depth of matrix strain and work hardening shown in Figure 9.20, although if compared to Figure 9.5 for Test 9 (R52 at 1300 MPa  $p_o$  and 3%  $\gamma$ ), it appears that the near-surface hardness was at an equivalent level and that the wear surface hardness was less at this higher contact stress. Perhaps the high plastic flow of the flakes was an additional mechanism, "feeding" the loss of flake tips whilst cementite lamellae alignment remained a protective mechanism.

**Figure 9.20** Wear surface circumferential section through a R52 top driven disc, LEROS tested at 1800 MPa  $p_o$  and 1.5%  $\gamma$  (Test 46). This disc is shown in Figure 8.8.

- (a) Overview showing the deep and thorough degree of ratchetting and pronounced surface flaking.
- (b) Detail showing aligned matrix by a flake root and alignment disruption from crack face friction.
- (c, d) Shown overleaf....

(c) Ratchetting alignment of pearlite lamellae 0.33mm sub-surface and  
(d) 0.56mm sub-surface.

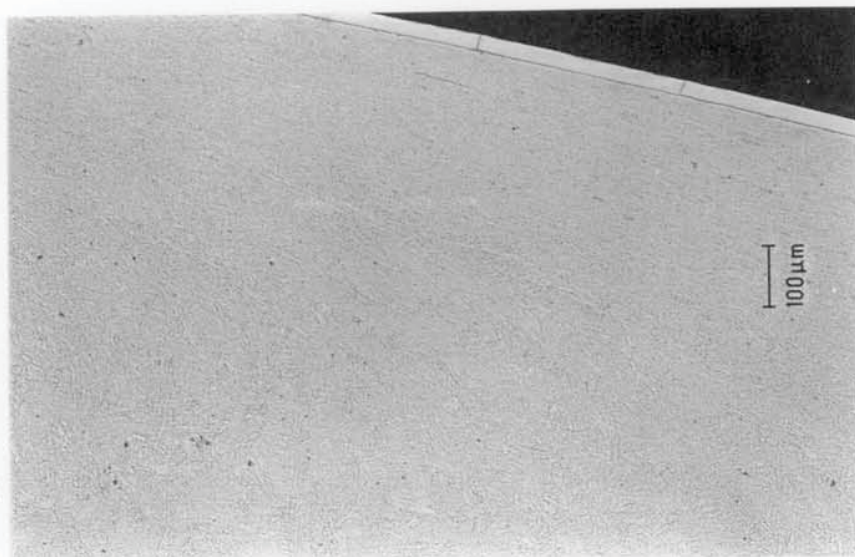
taken through the worn B04 disc, contained only one sizeable flake plus occasional small flakes of a few microns depth. The matrix was extensively strained with deep alignment of hard MA phase particles (Figure 9.22). However, these particles were discrete with areas of strained ferrite between them. Perhaps flakes generated from such a structure were removed within one contact cycle of the rollers, however this would pre-suppose a high wear rate. (Figures 9.22b and c also clearly shows the difference in behaviour between ductile and brittle inclusions; Mns has been flattened whereas TiN has retained its shape and has thus initiated micro-cracks. However, it was felt that size and number of both types of inclusion were too low to make any significant contribution to the wear of these three bainitic steels.)

**Figure 9.22** Wear surface circumferential section through a B04 top driven disc, LEROS tested at 1800 MPa  $p_o$  and 1.5%  $\gamma$  (Test 47). This disc is shown in Figure 8.36.

- (a) Overview showing ratchetting beneath smooth surface.
- (b) Near-surface detail showing small pancaked MnS inclusions and a tiny surface flake.
- (c) Near-surface detail showing crack initiation on a brittle Ti-based inclusion.

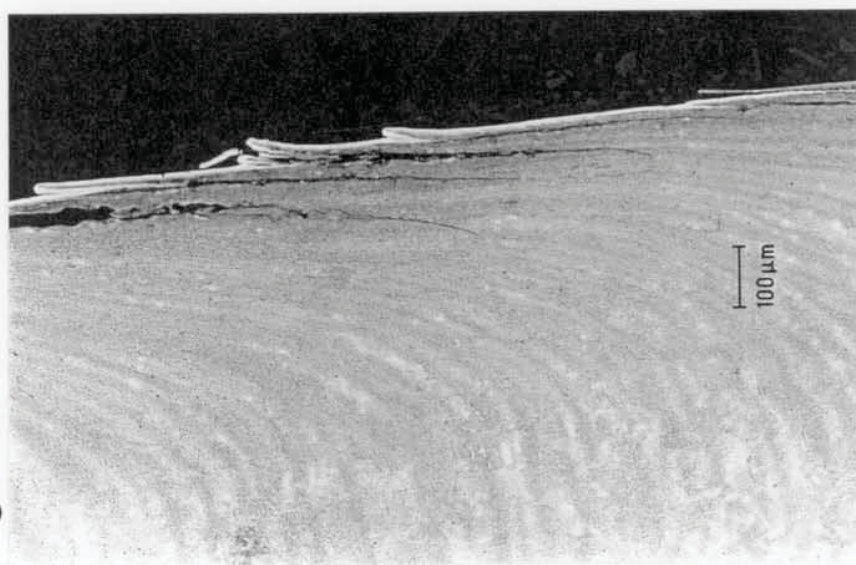
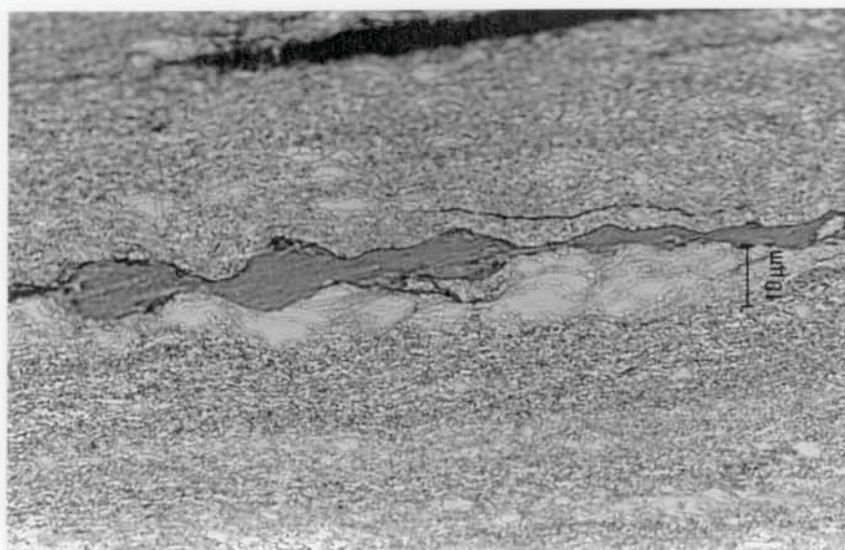
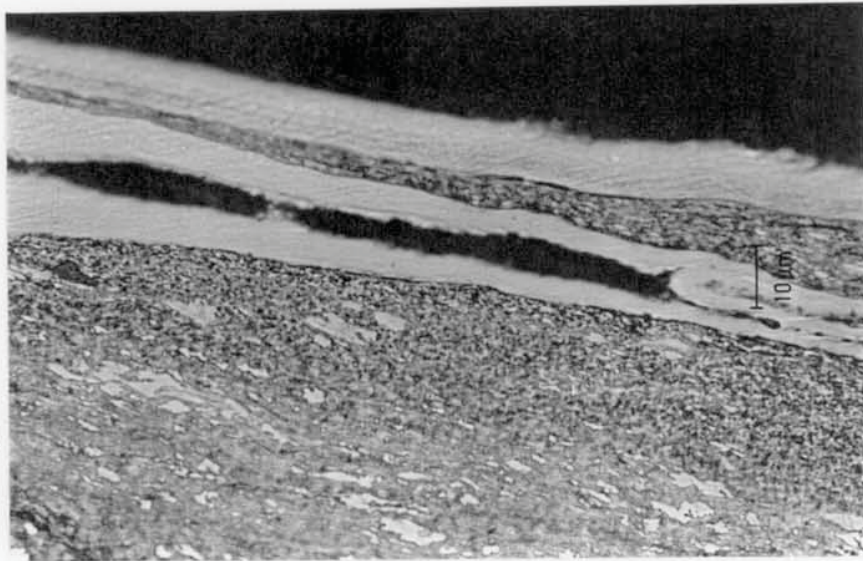
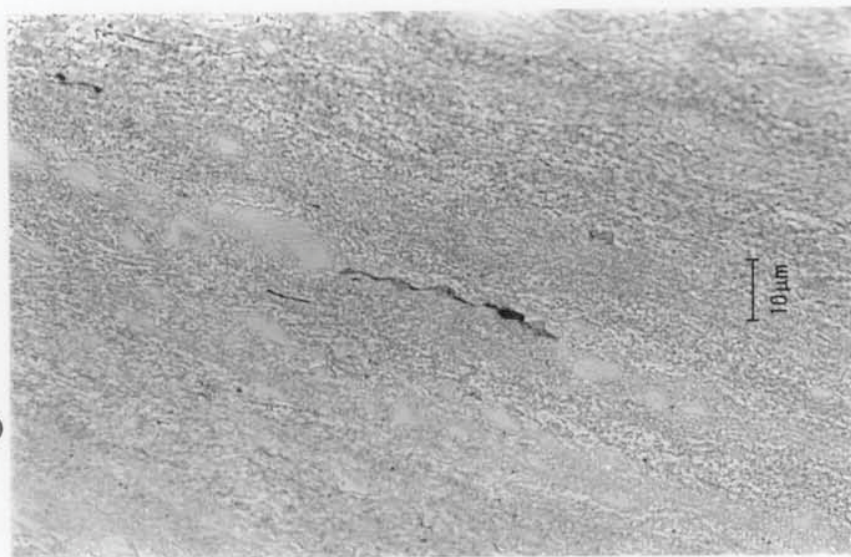
The B52 section is shown in Figure 9.26. Near-surface flaking features were similar to those seen for R52 and B20. Hardness survey results are shown in Figure 9.27. Sub-surface, the pattern is similar to B20, but surface hardening was slightly higher. The lath structure of the upper bainitic areas had been completely broken down by the high near-surface stresses, whereas the lower bainitic areas have been only partially, plastically deformed. Unlike the B04 disc tested under the same conditions (Figure 9.22), shear stresses in the matrix have been sufficient to fracture brittle TiN inclusions. In this instance, microcracks have linked the fractured particles (Figure 9.26d). Cracks were not observed to have formed between the upper and lower bainitic areas, as seen under milder test conditions (Figure 9.11).

**Figure 9.26** Wear surface circumferential section through a B52 top driven disc, LEROS tested at 1800 MPa  $p_o$  and 1.5%  $\gamma$  (Test 49). This disc is shown in Figure 8.37b.  
 (a) Overview showing ratchetting and dense surface flaking.  
 (b) Detail of flake crack showing disruption of matrix alignment from crack face friction and rigid lower bainite / martensite zones. These have begun to deform near the surface.  
 (c, d) Shown overleaf....

- (c) Deformation and strain alignment of all parts of the structure at the surface.
- (d) Ratchetted structure 0.12mm sub-surface and crack initiation on a brittle, fractured Ti-based inclusion.

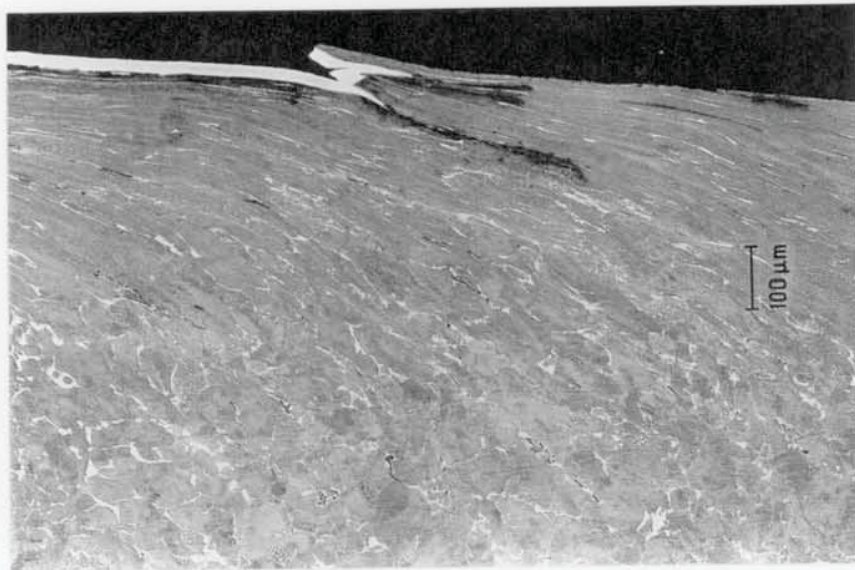
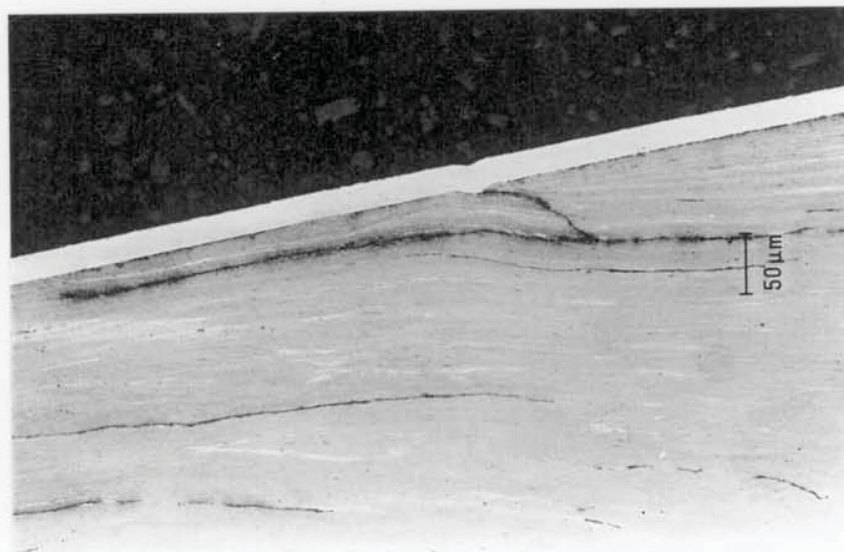
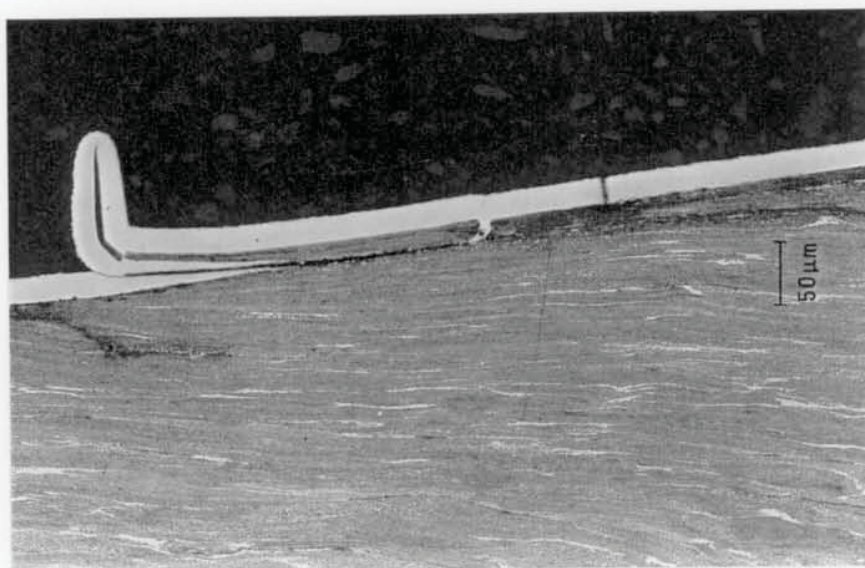
Bottom W64 "driving" discs suffered severe wear under these test conditions, irrespective of the counter top disc material. Wear surface surveys indicated that a major wear mechanism had been low cycle fatigue fracture of thick flakes (Figures 8.38 and 8.39). Flake cracks propagated down to depths of 160 $\mu$ m, as shown in a section of the Test 48 W64 disc (Figure 9.28). There was some sub-surface crack initiation on, and along, pancaked MnS stringers and where propagation of steeply angled surface flake cracks reached such inclusions, thick plates of material had spalled off.

**Figure 9.28** Wear surface circumferential section through a W64 bottom driving disc, LEROS tested against B20 at 1800 MPa  $p_o$  and 1.5%  $\gamma$  (Test 48). Surface shown in Figure 8.39.  
(a) Duplex flaking, thick truncated flakes.  
(b) Surface fatigue fracture down to crack plane along pancaked MnS.  
(c, d) Shown overleaf...

(c and d) Block fracture of a flake and, to the left, another crack down to a crack plane initiated along pancaked MnS.

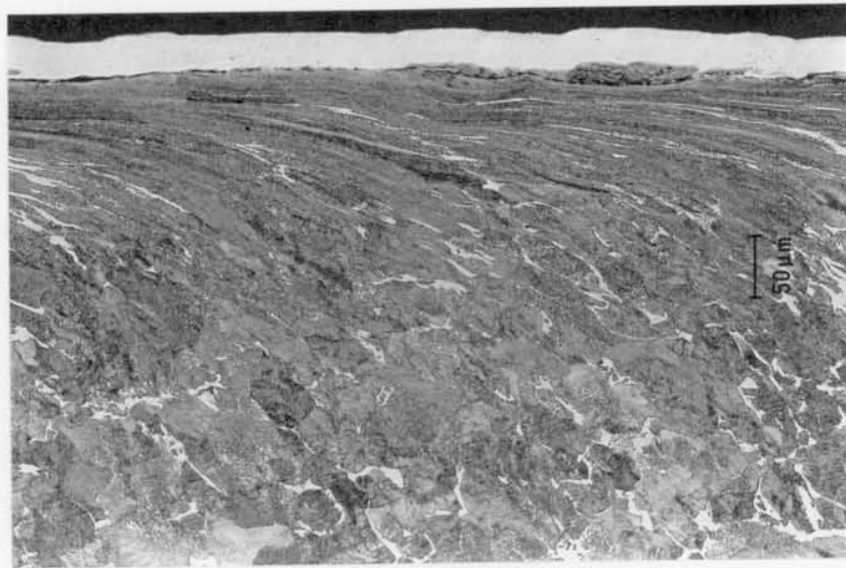
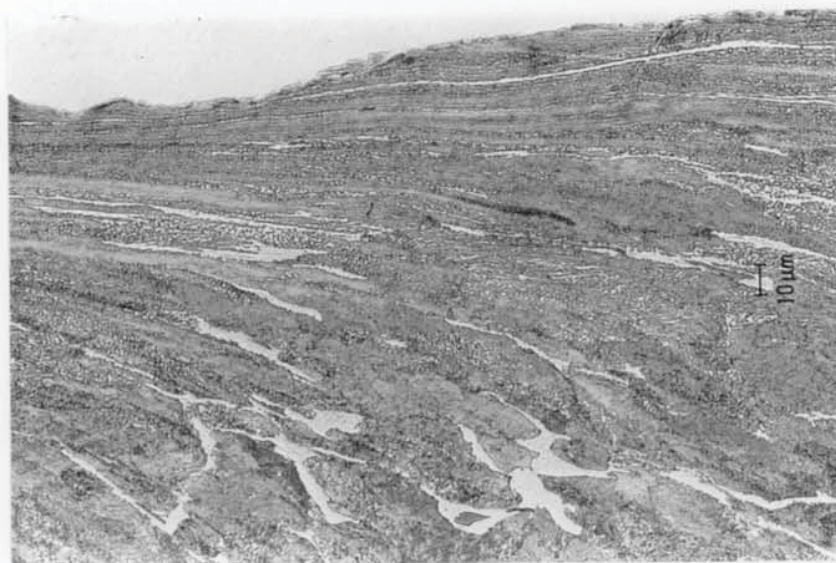
Comparative microsections were taken through the bottom W64 discs of Test 42 (lower wear, against R52) and Test 44 (the highest wear rate, against B20). Possible wear mechanisms were discussed in Section 8.6, where it was suggested that different modes of surface "rippling" of each top driven disc might have induced differing degrees of surface (i.e. cementite alignment) disruption and local stress, thus affecting low cycle fatigue failure. The section through the lower wear rate Test 42 W64 disc is shown in Figure 9.29 and the section through the higher wear rate Test 44 W64 disc in Figure 9.30. The Test 44 disc appears to have been far more highly strained, with a greater degree of surface disruption and fatigue. This was reflected in the micro-hardness surveys (Figures 9.31 and 9.32 for Tests 42 and 44, respectively). The degree of sub-surface strain was higher in the Test 44 disc, but the surface hardness was lower, perhaps due to the greater disruption affecting the

**Figure 9.29** Wear surface circumferential section through a W64 bottom driving disc, LEROS tested against R52 at 1300 MPa  $p_o$  and 10%  $\gamma$  (Test 42).  
(a) Overview showing undulating surface and some debris adherence.  
(b) The ratcheted structure near the undulating surface.

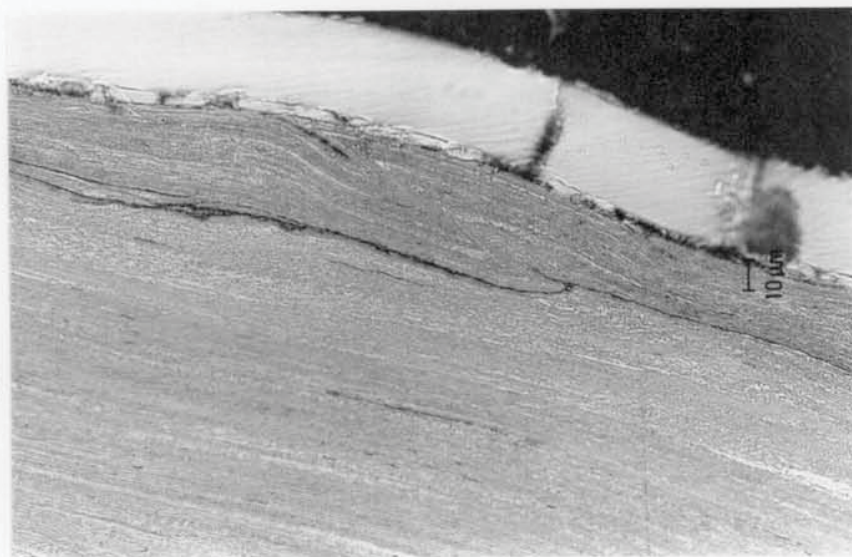
**Figure 9.30** Wear surface circumferential section through a W64 bottom driving disc, LEROS tested against B20 at 1300 MPa  $p_o$  and 10%  $\gamma$  (Test 44). The disc surface is shown in Figure 8.56.

(a) Overview showing a far more ratcheted structure than seen in Figure 9.29 and, again, fatigue fracture down from the surface to crack planes based on pancaked MnS inclusions.

(b) Detail of fatigue fracture.

(c) Detail of material flow between the surface and a sub-surface crack plane.

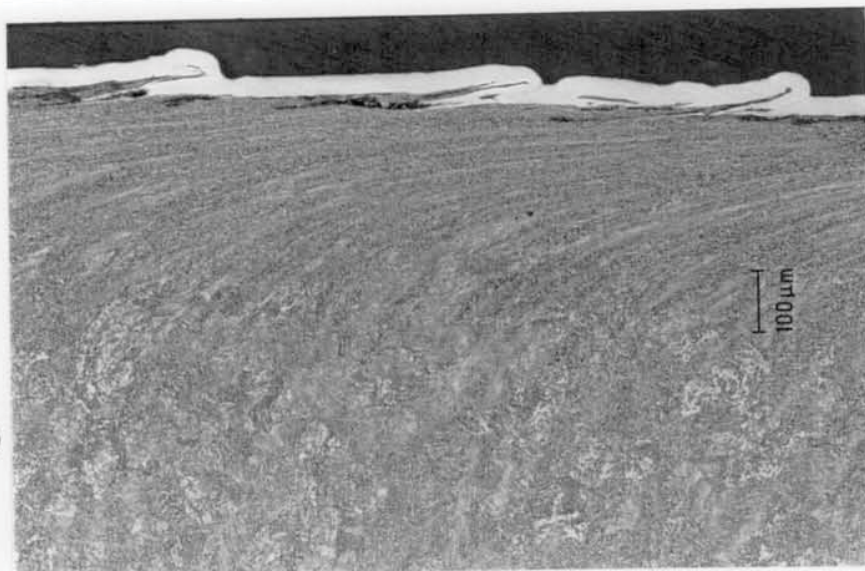
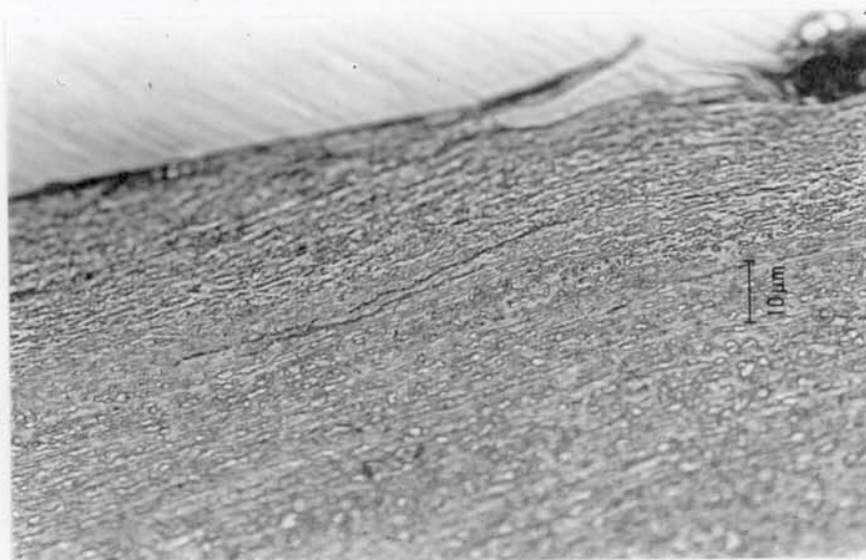
A section was taken through the top "braking" B20 disc (Test 44) tested under these conditions (Figure 9.33), for comparison with the B20 disc tested under the high stress, low creepage conditions described earlier (Figure 9.24, Test 48). Under the high creepage, low contact stress conditions (Test 44), the near surface, hard MA phase particles appeared to have been more plastically deformed. However, there are still discrete areas of ferrite, presented to the wear face, between the particles. Alignment of deformed particles has been disrupted by surface rippling. There were numerous small flakes generated on the ripples. The inclusions present, although low in volume, were also highly elongated, thus presenting some planes of weakness. The micro-hardness survey of the section is given in Figure 9.32. If compared to the Test 48 survey (Figure 9.25), the degree of sub-surface hardening was slightly less, as expected at a lower contact stress, but the degree of surface hardening was higher, perhaps reflecting the greater deformation and alignment of hard phases at this higher creepage. A mechanism that appears to favour the pearlitic structure, hence its comparatively low wear rate under these conditions, once surface disruption has been minimised.

**Figure 9.33** Wear surface circumferential section through a B20 top driven disc, LEROS tested at 1300 MPa  $p_o$  and 10%  $\gamma$  (Test 44). The disc surface is shown in Figures 7.17c and 8.57.

- (a) Overview of ratcheted structure and surface flaking.
- (b) Detail of aligned MA phase near the surface.
- (c) Detail of fine, pancaked MnS. Here, no planar cracks have been initiated.

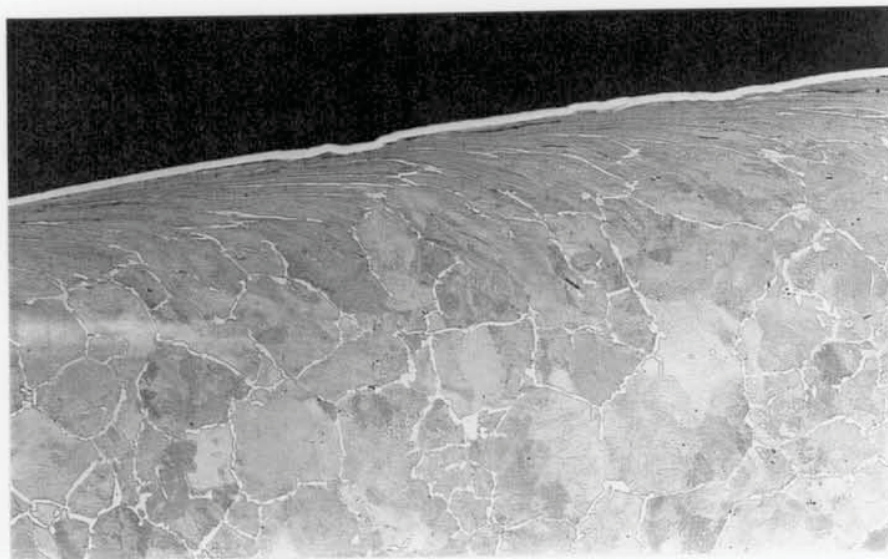
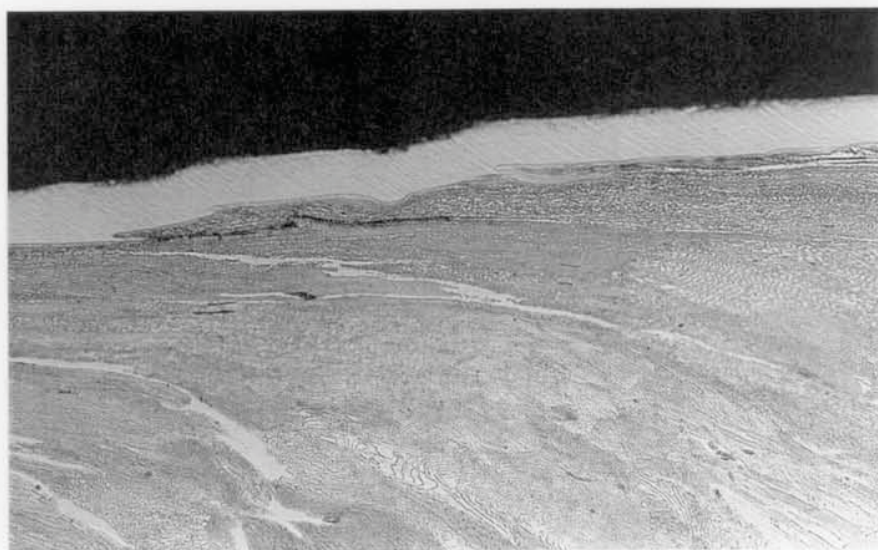
Wear surface microstructures of the top R52 and bottom W64 discs of Test 25 are shown in Figures 9.34 and 9.35; microhardness surveys are shown in Figure 9.36. The depth of strain hardening was shallow, with cementite lamellae alignment near to the surface. The rapid drop-off from a high worn surface hardness can be seen in Figure 9.36 for both top and bottom discs. Rolled-in debris appears to have partially

**Figure 9.34** Wear surface circumferential section through a R52 top driven disc, Amsler tested at 884 MPa  $p_o$  and 10%  $\gamma$  (Test 25). The disc surface is shown in Figures 8.47b and 8.51a.  
(a) Overview, ratchetting beneath undulating surface.  
(b) Detail of short surface flakes.
