## CHAPTER 9

### MICROSTRUCTURES of WORN DISCS

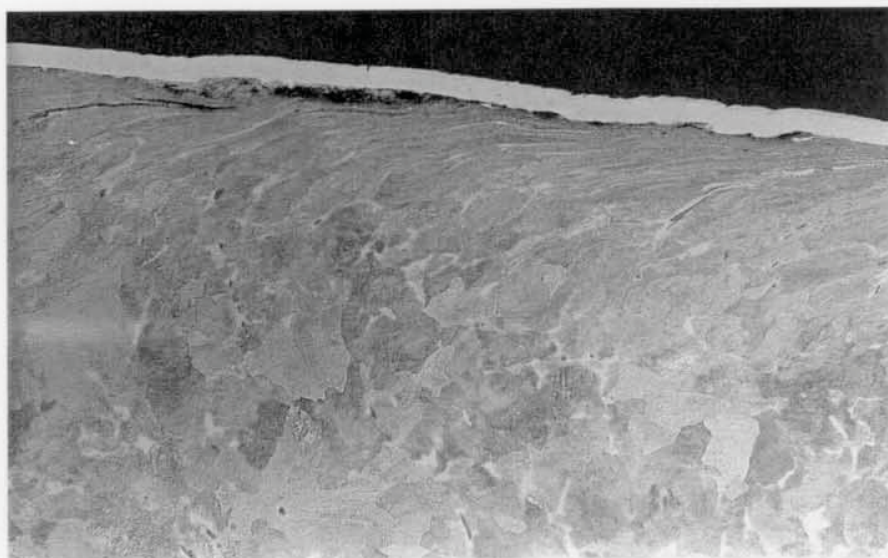
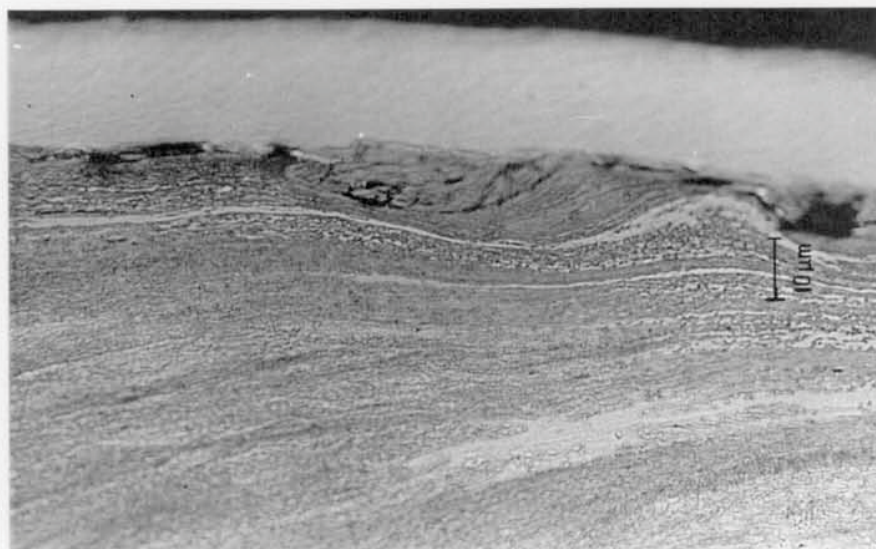
**Figure 9.35** Wear surface circumferential section through a W64 bottom driving disc, Amsler tested against R52 at 884 MPa  $p_o$  and 10%  $\gamma$  (Test 25). The disc surface is shown in Figure 8.47b.  
(a) Overview, ratchetting beneath undulating surface.  
(b) Surface detail, adhered debris.

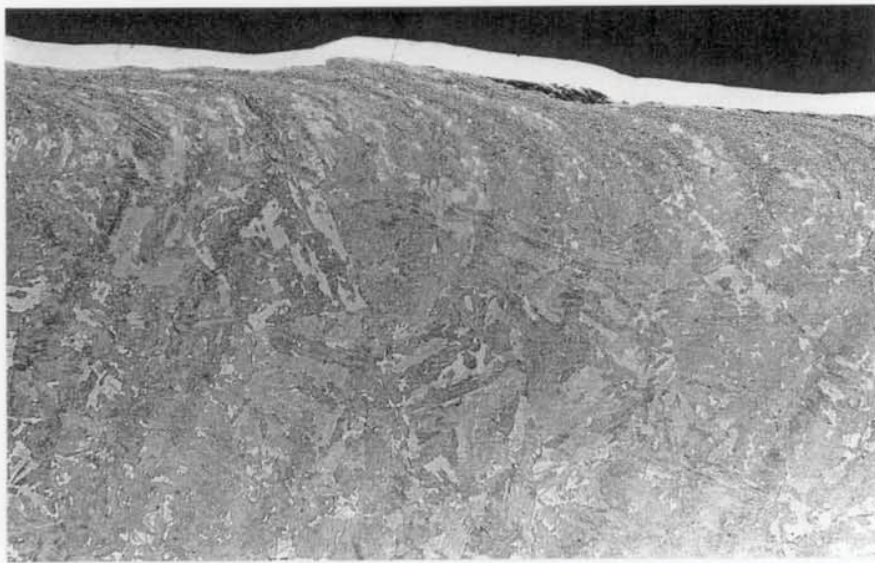
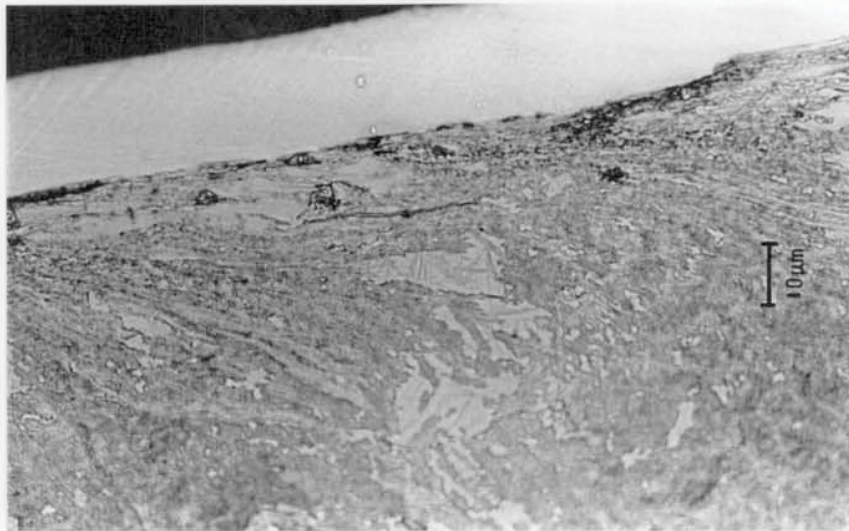
**Figure 9.40** Wear surface circumferential section through a B52 top driven disc, Amsler tested at 884 MPa  $p_o$  and 10%  $\gamma$  (Test 22). The disc surface is shown in Figure 8.51c.  
(a) Overview of ratchetting, undulating surface and adhered debris.  
(b) Detail of differential degree of matrix strain near the surface between the upper bainite areas (dark) and the lower bainite / martensite areas (light).

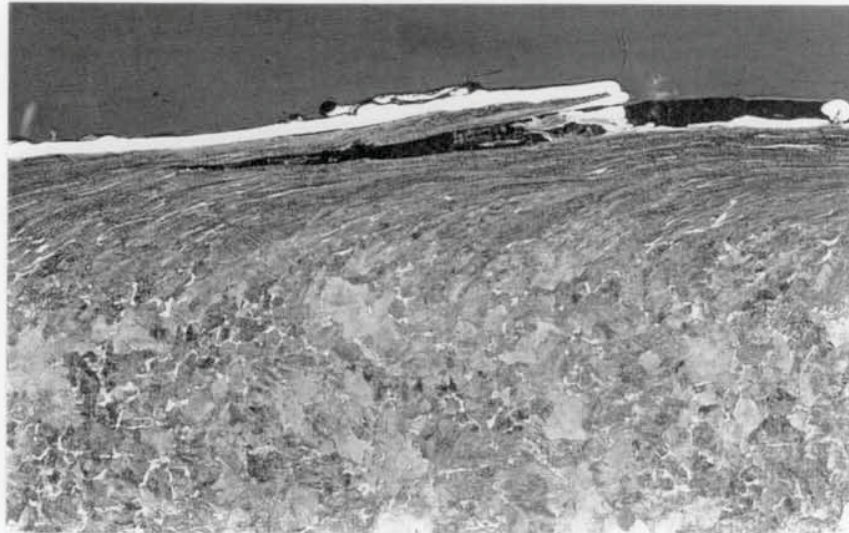
(x85 mag.)

**Figure 9.41** Wear surface circumferential section through a W64 bottom driving disc, Amsler tested against B52 at 884 MPa  $p_o$  and 10%  $\gamma$  (Test 22). Overview of ratchetting and generation of thick flakes.
